Safety Alert

Near miss with two track workers near Kettering

Ref: NRX21-02

Date: 08/10/2021

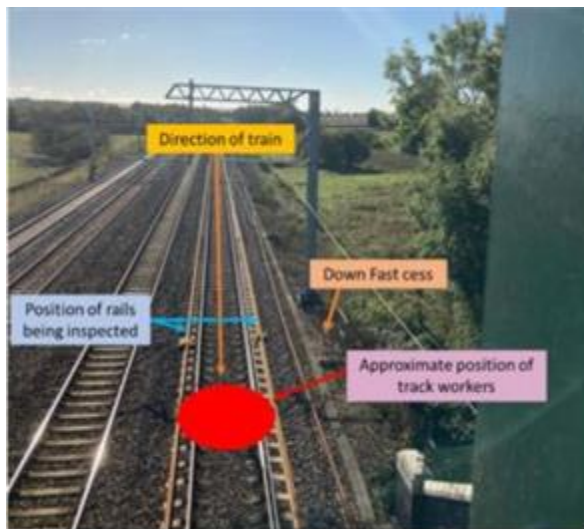
Picture: Location of near miss.

The track workers had been checking lengths of rail that had been dropped in the location ahead of renewal works, remained in a safe position not affecting running rails. Their safe system of work was 'separated by distance', allowing them to visually check rails from the Down cess. However, overhead line stanchions and an overbridge affected being able to stay the required distance from running lines.

- Review all SWPs for forthcoming works where the safe system of work is separation.
- Verify that the planned activities can be safely performed this way at each specific location.
- Identify whether there are safer alternative means of performing tasks, i.e. removing the need for people to go on track.
